Manhole Inspection Summary

Manhole # S25GG_025MH

Insp Date: **9/10/07 9:43 AM**

Location Address: **574 PRESSTMAN ST**

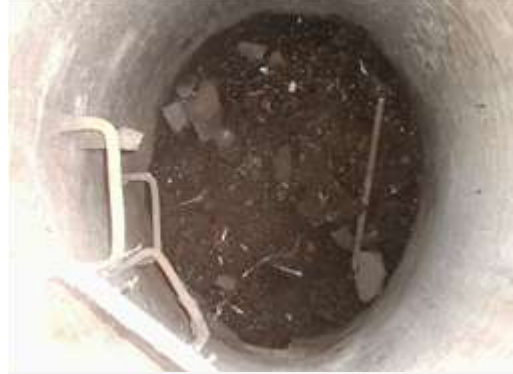
Top View

Corroded steps. Channel debris.

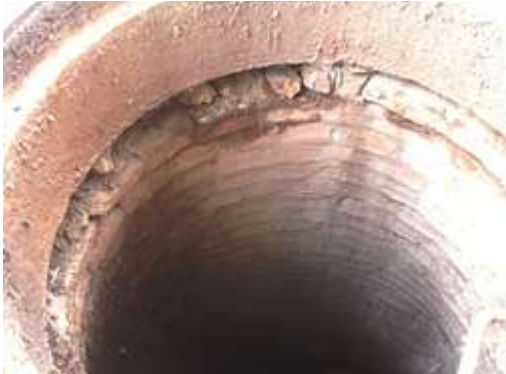
Defect

Frame leaks. Adjustment deterioration, loose brick and infiltration. Corbel infiltration - other side.

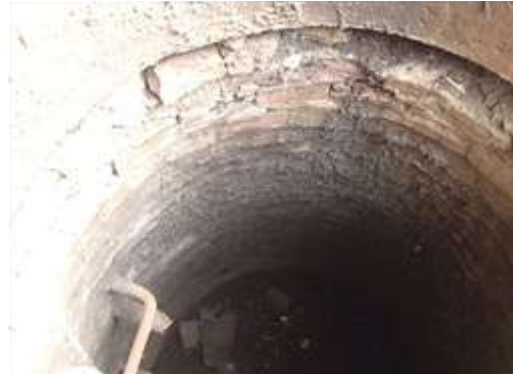
Defect

Frame leaks. Adjustment deterioration, loose brick and infiltration. Corbel infiltration.

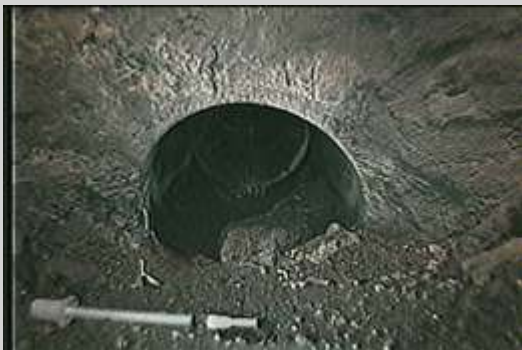
8 in. Circular Gravity Sewer
Pipe Out @ 12 O'Clock

Barrel deterioration and infiltration.
